Executing a Capital Improvement Plan Using Outside Funding

24th Annual Surface Water Meeting October 18, 2023

Jonathan R. Bonner, P.E., CFM Insite Engineering, LLC Tuscaloosa, AL

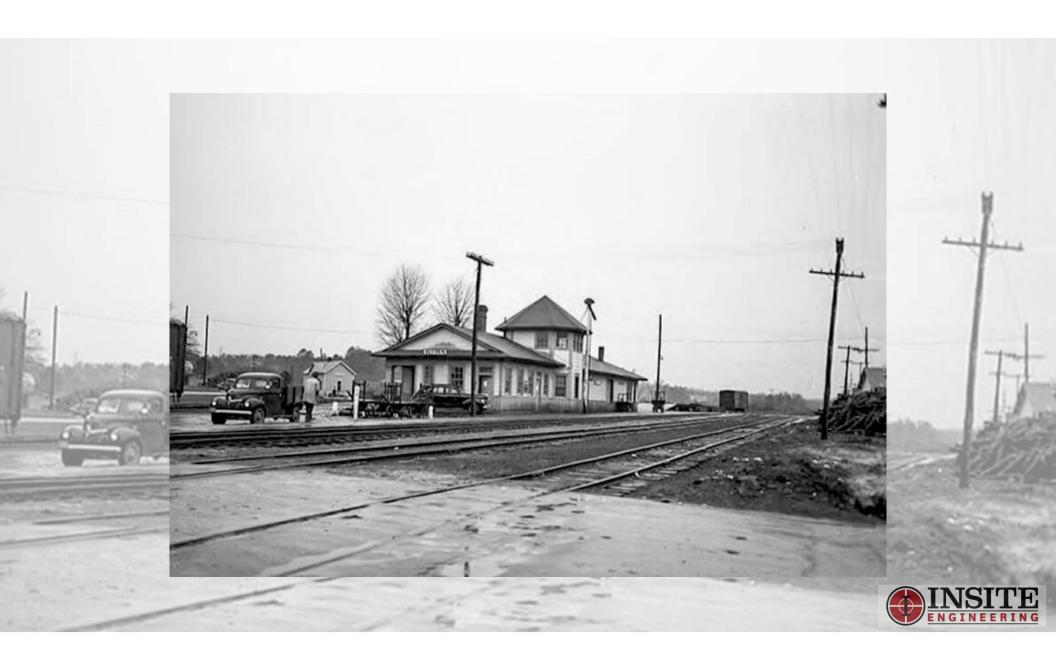
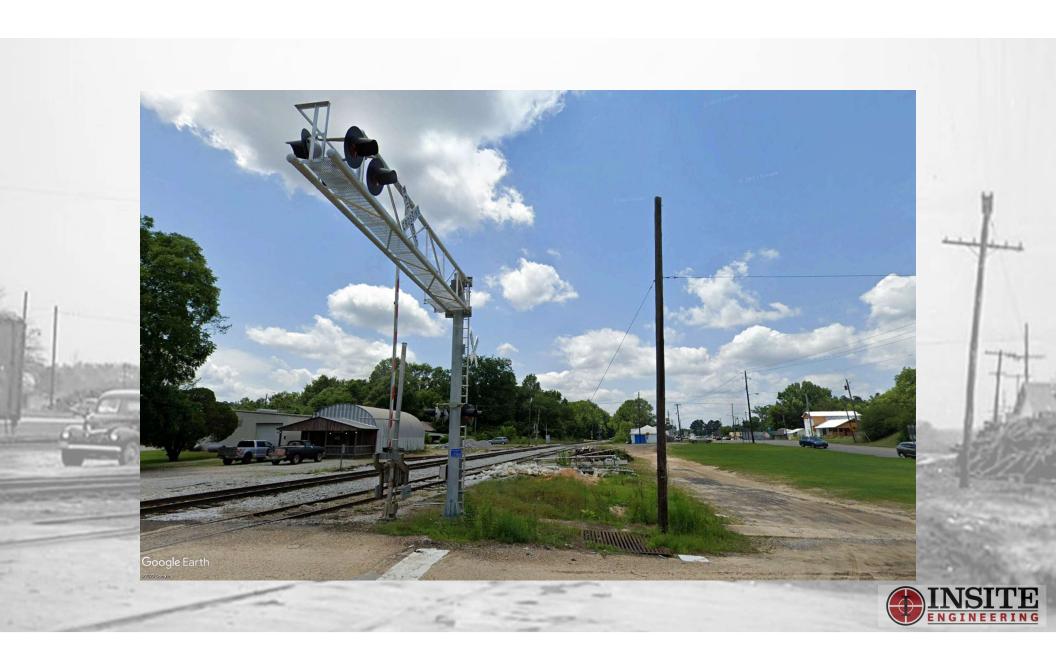
- Water system dates to 1926
- Much of the older system is still in place in the downtown area
- Had one well and one elevated tank
- Both gone now

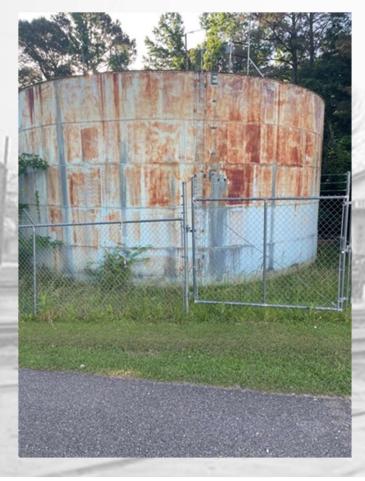
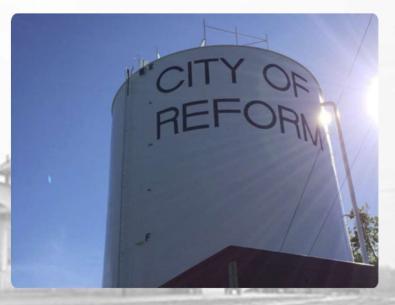
- A 500,000-gal Storage Tank from 1988
- A 500,000-gal Storage Tank Taken Offline in 2021

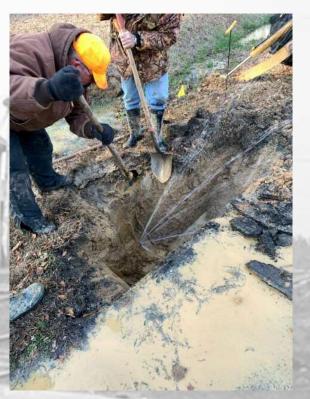
Distribution

- 60 miles of water mains
- 50 miles of Cast/Ductile Iron
- 10 miles of PVC
- (Best estimates)
- Do have radio-read meters!

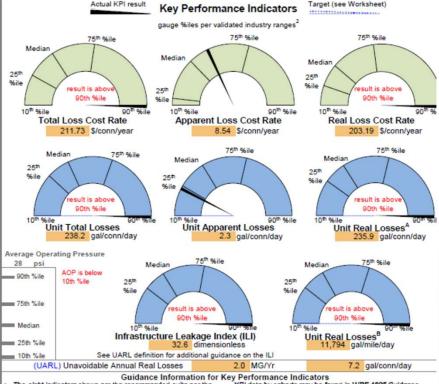
- The eight indicators shown are the recommended suite per the AWWA Water Loss Control Committee 2020 Position on KPIs1
- A suite of KPIs is necessary, as no single KPI can holistically communicate water loss performance for a given water system

- 11,794 gal/mile/day
- Well over 50% NRW
- Estimated cost of NRW \$159,047/year
- 90th %tile of water losses in US

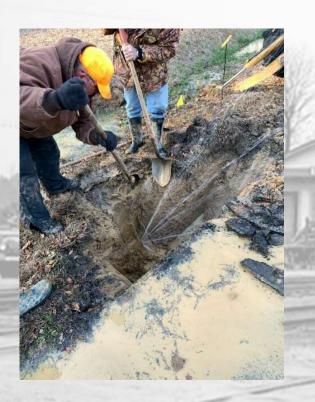
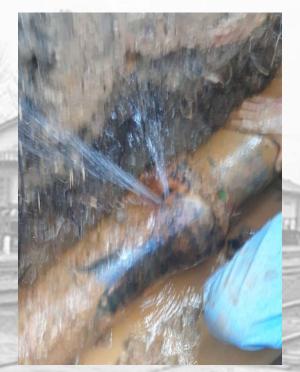
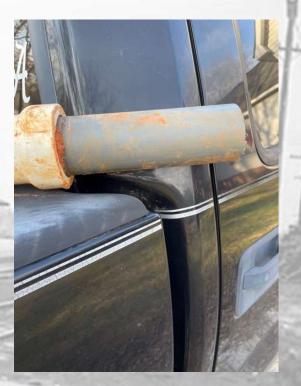
Underwent extensive repairs for leaks to restore water

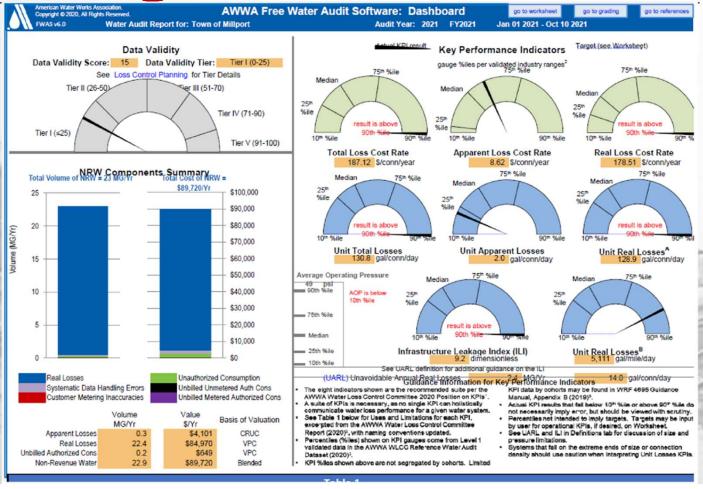
High Water Losses

- NRW due to:
 - Maintenance on current filter
 - 60,000 gal/day
 - Iron removal plant leaks
 - Been repaired many times
 - Fabricated from aluminum
 - Not compatible with chemistry
- Operate "Split" system

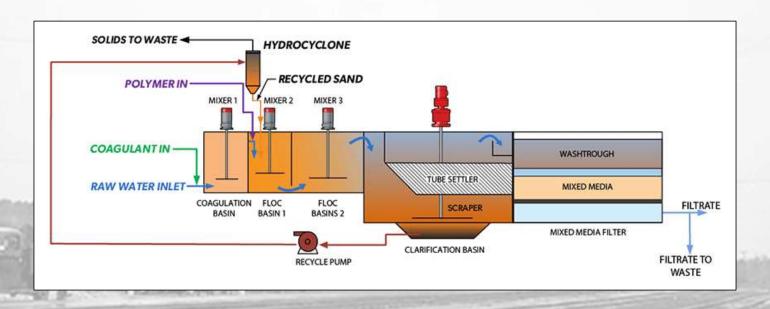
Proposed Water Treatment Plant

- Replace Standpipe tank
- Install package treatment plant
- Replace corroded aluminum plating

- Funding For:
 - WesTech RapiSand Plus™
 - Existing Filter Unit Repair
 - Booster Pump Feed Tank Construction
- Need for Proposed Facilities
 - Increased Water Demand
 - Need for Increased Capacity
 - Need for Increased Capability
